Emergency Action Plan (EAP)

FAWN LAKE DAM

DCR Inventory Number: 177009

A. Morton Thomas and Associates, Inc.

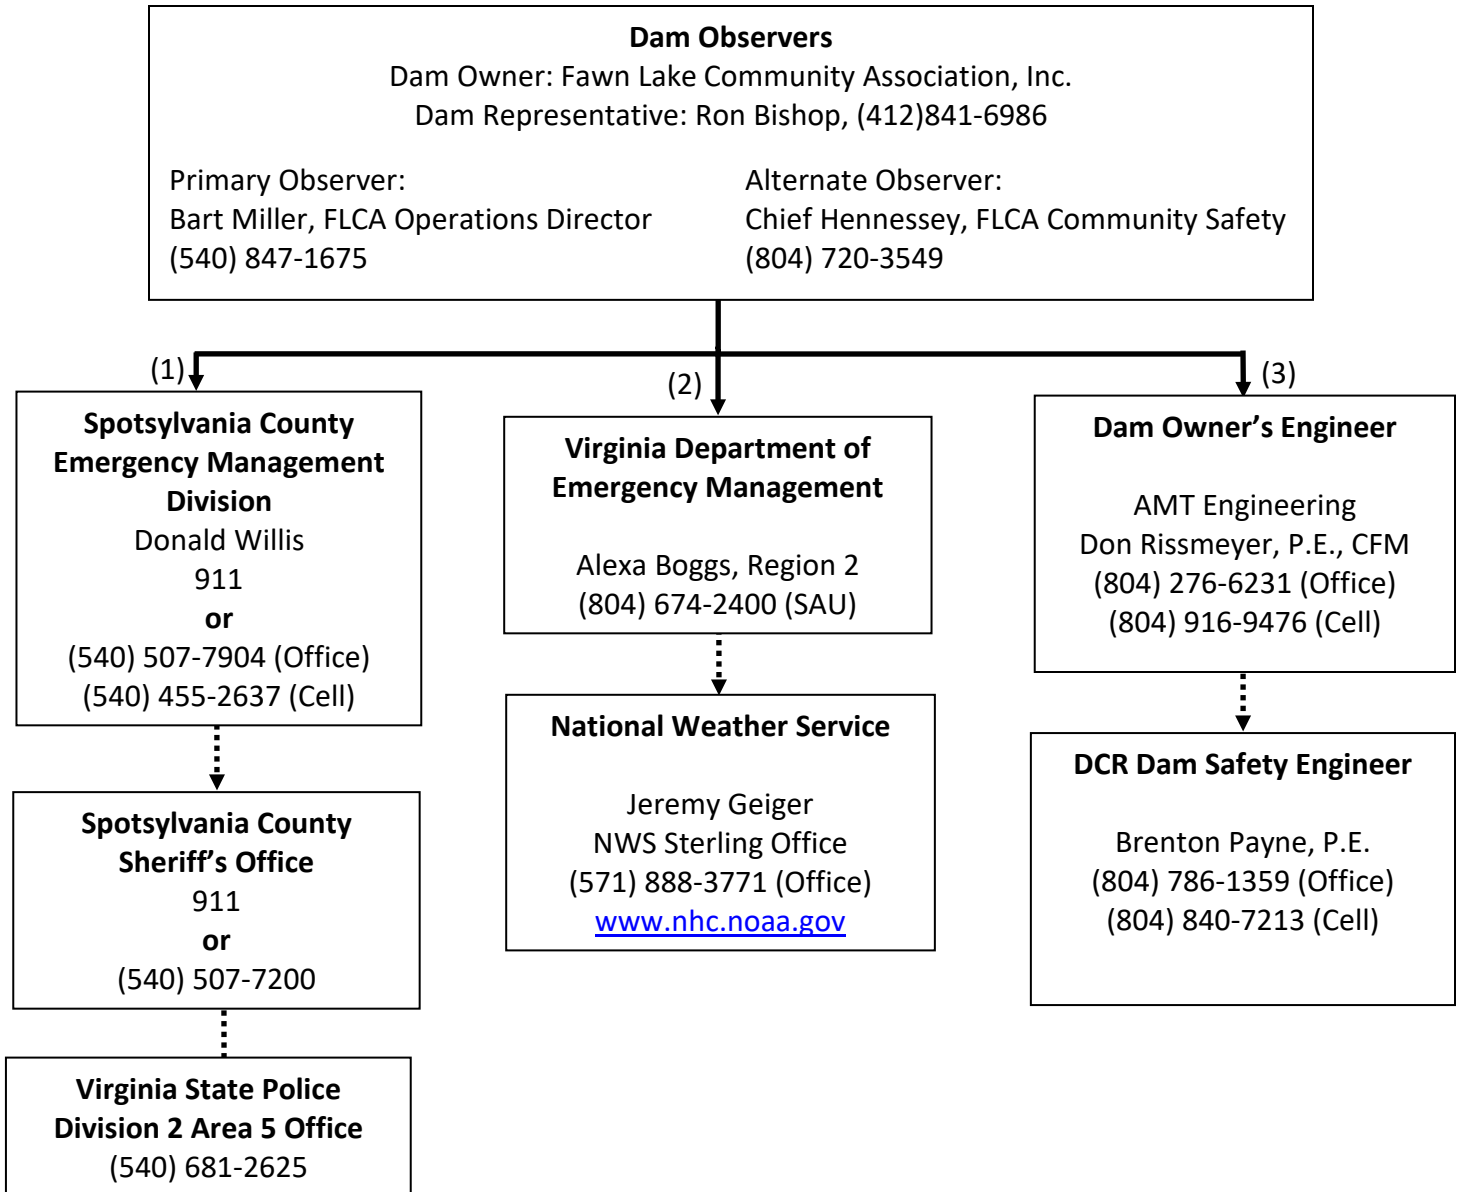
Emergency Level 2 Notifications

Emergency Event, Potential Dam Failure Situation Rapidly Developing; Rainfall is to Exceed 9.6 Inches in 6-Hours, 10.6 Inches in 12-Hours, or 12.2 Inches in 24-Hours; or Predetermined Trigger Pool Elevation of 1 Foot of flow in the Emergency Spillway (340') and rising.

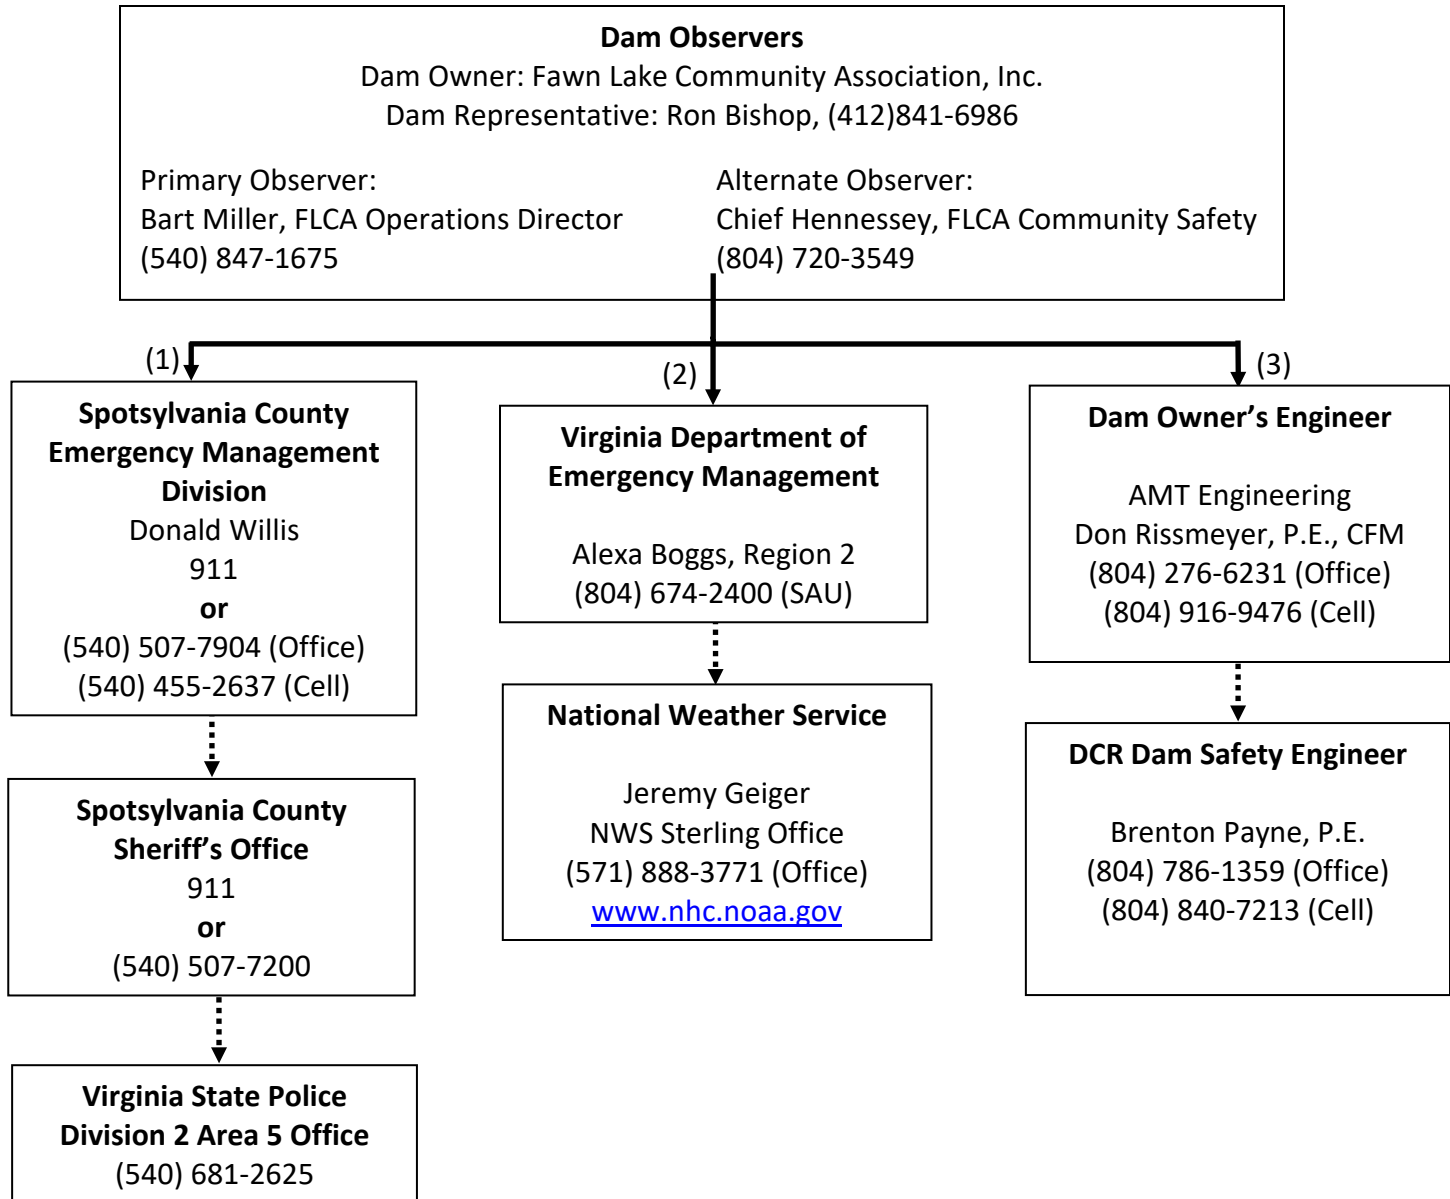
Emergency Level 3 Notifications

Urgent Event: Dam Failure Appears Imminent or is in Progress; Rainfall is to Exceed 12.4 Inches in 6-Hours, 14.6 Inches in 12-Hours, or 17.0 Inches in 24-Hours; or Significant Flow in the Principal Spillway; or Predetermined Trigger Pool Elevation of 2 feet of flow in the Emergency Spillway (341') and rising.
